PRIMROSE UPDATE

Reporting Period August 25 - 31, 2013

Canadian Natural

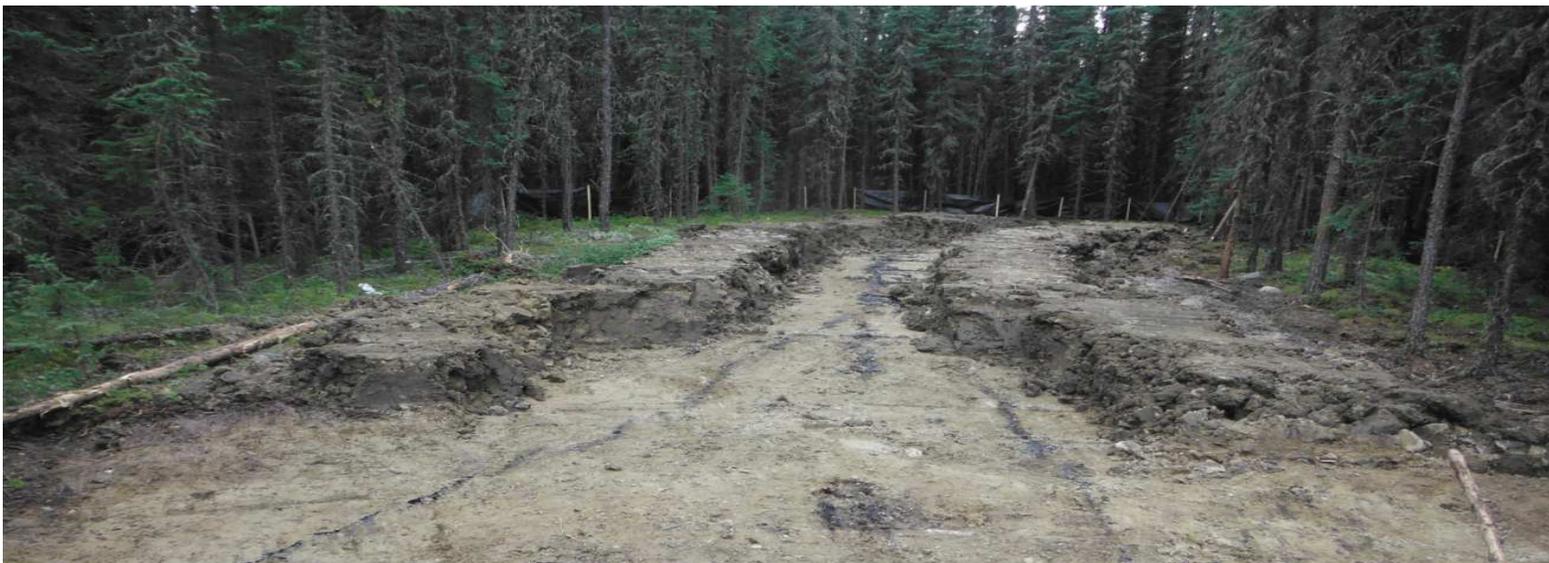
Exposed Fissure at 2-22
