MONTHLY UPDATE REPORT - PRIMROSE SOUTH 09-21-067-04 W4M

OCTOBER 21 TO NOVEMBER 17, 2014

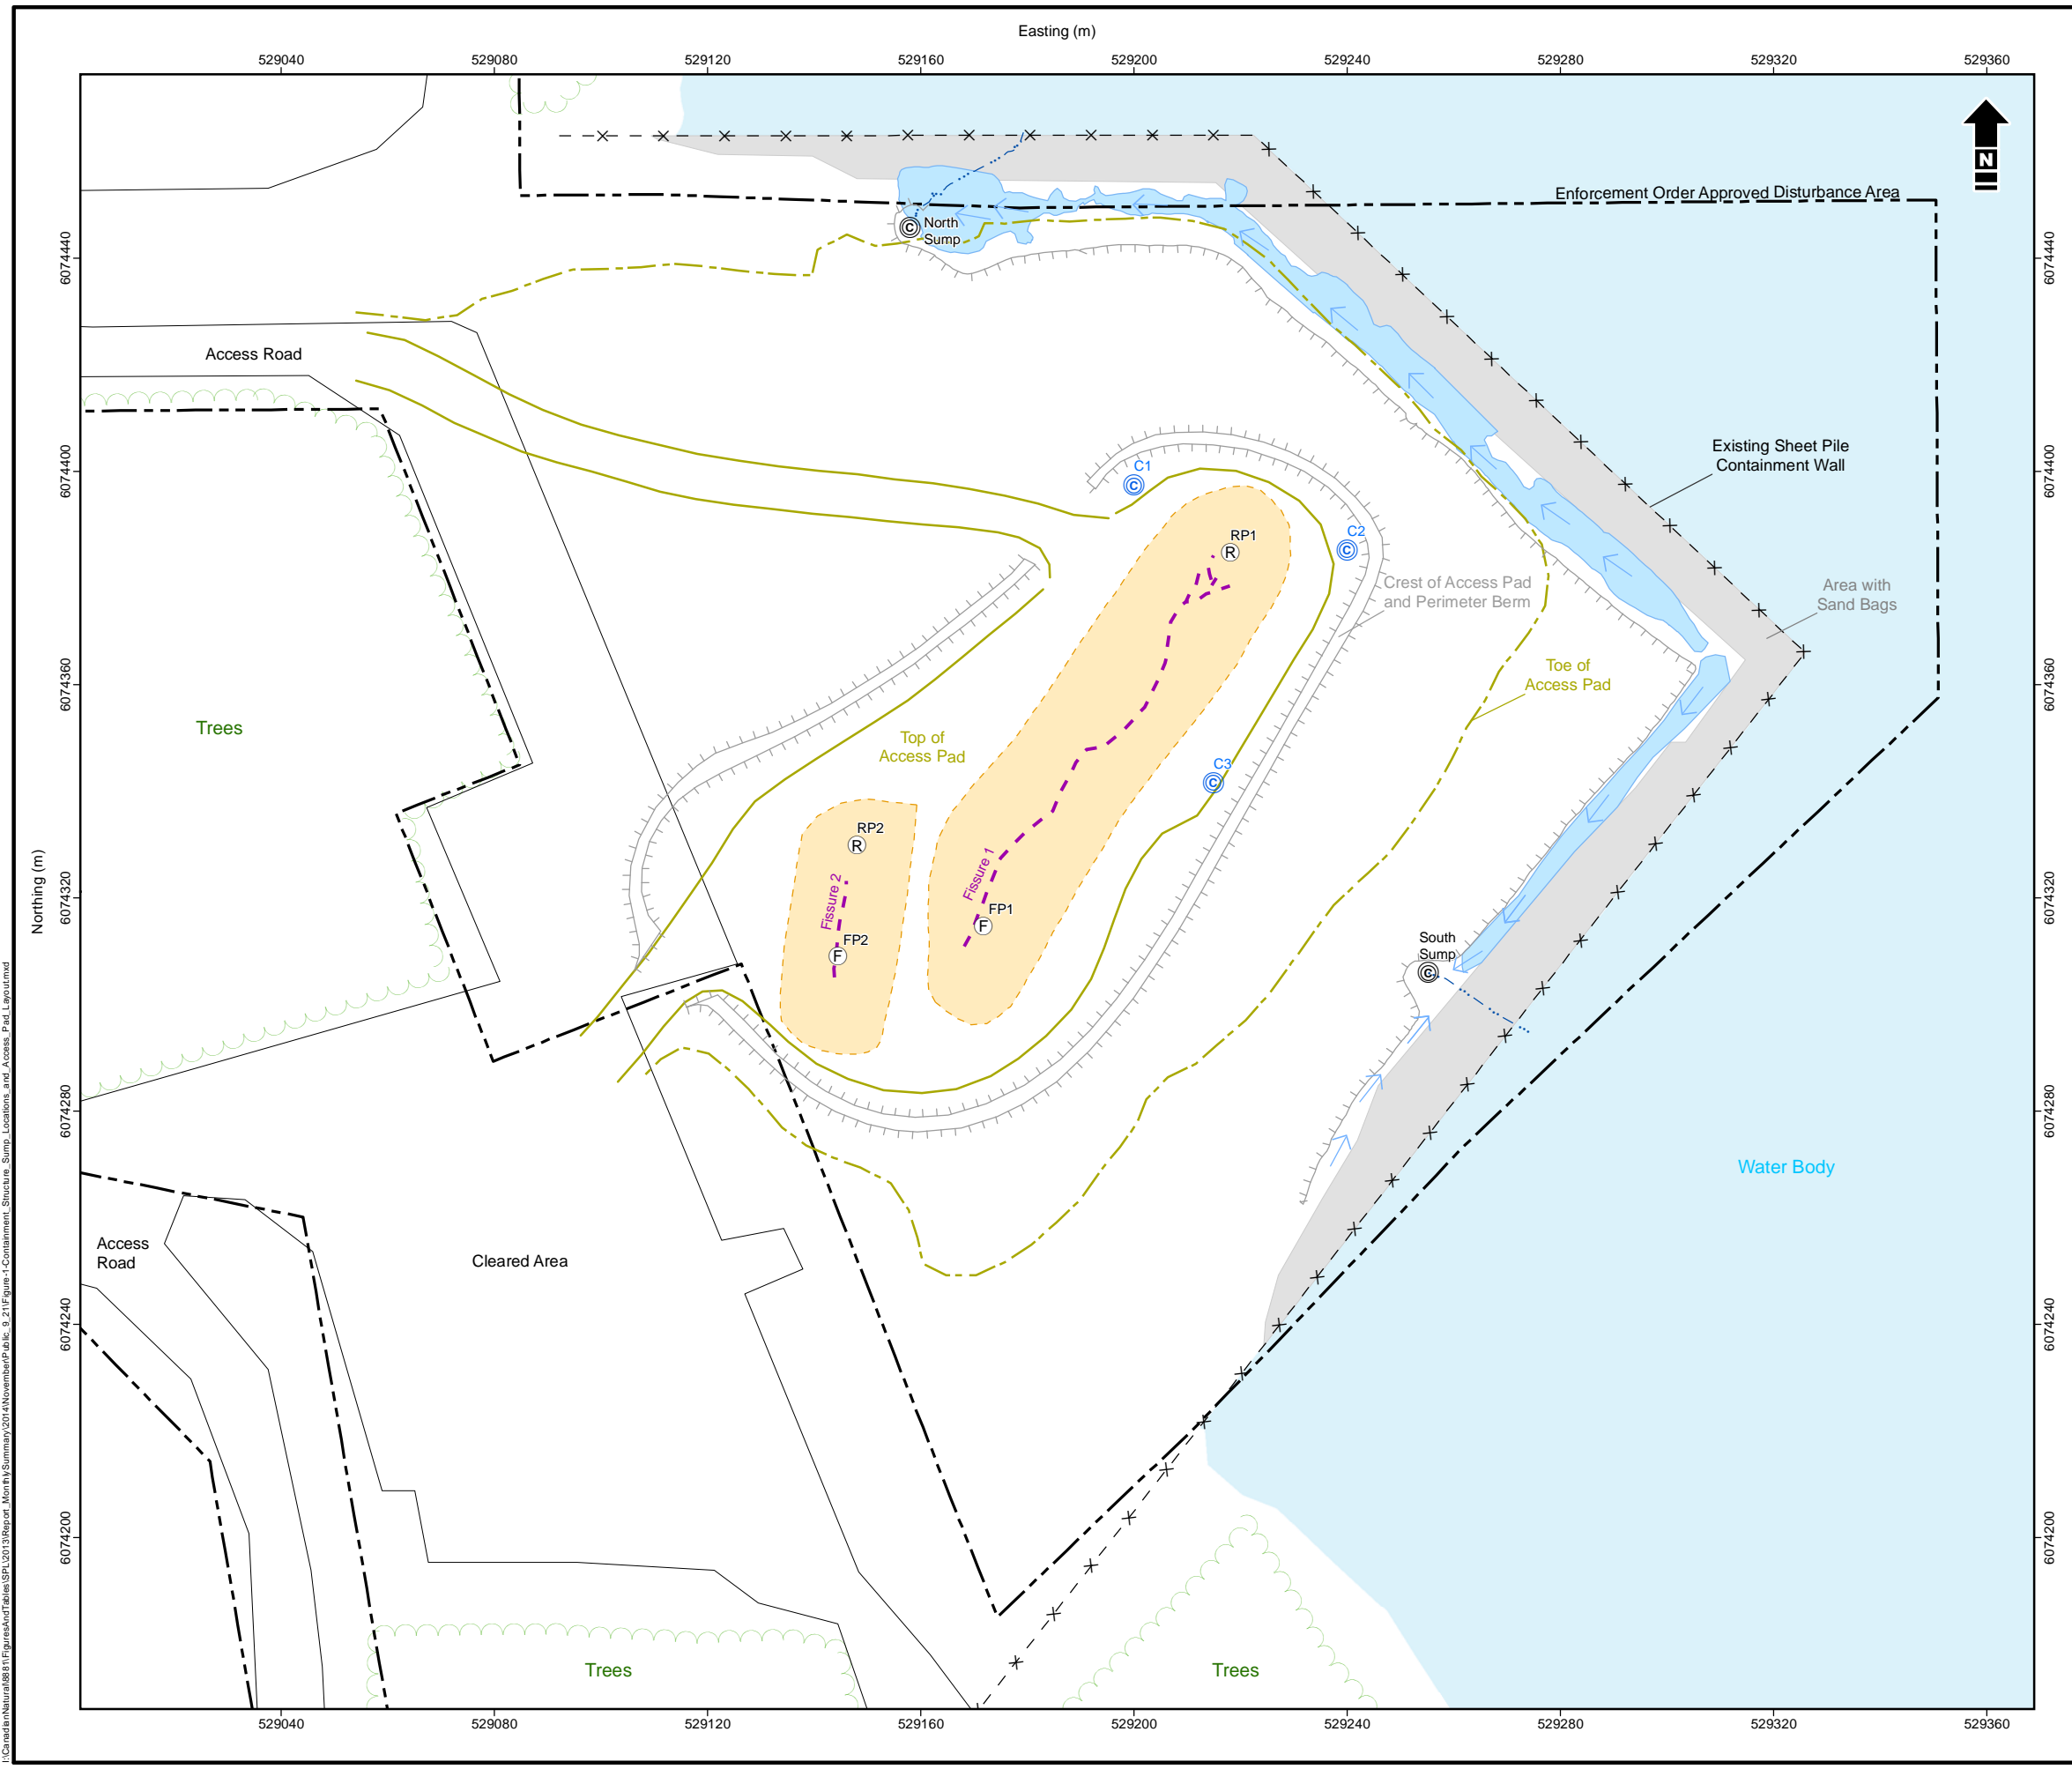
Containment Structure Sump Locations and Access Pad Layout

Water that seeped across the containment wall was collected and pumped from inside the containment wall back into Basin 1 from two sumps located on the north and south sides of the wall (Figure 1). Water

was pumped from the two sumps using automated sump pumps that were operational throughout the reporting period. A sheen was observed in the south sump on November 10, 2014 and pumping was suspended temporarily and the sheen was removed using absorbent pads. Sheen was not observed in the north sump or swale. Samples of water from inside the south and north sumps as well as from the south swale upstream of the south sump, were obtained and tested in the laboratory for concentrations of petroleum hydrocarbons (PHC). Results from the south sump, north sump and south swale upstream of the south sump (Upstream South) indicated that PHCs were not present. Results are presented in Appendix A1 and A2. Pumping into the water body resumed on November 12, 2014 when the analytical results were received. Daily monitoring of both the north and south sumps is being conducted and sheen has not been observed since November 10, 2014.

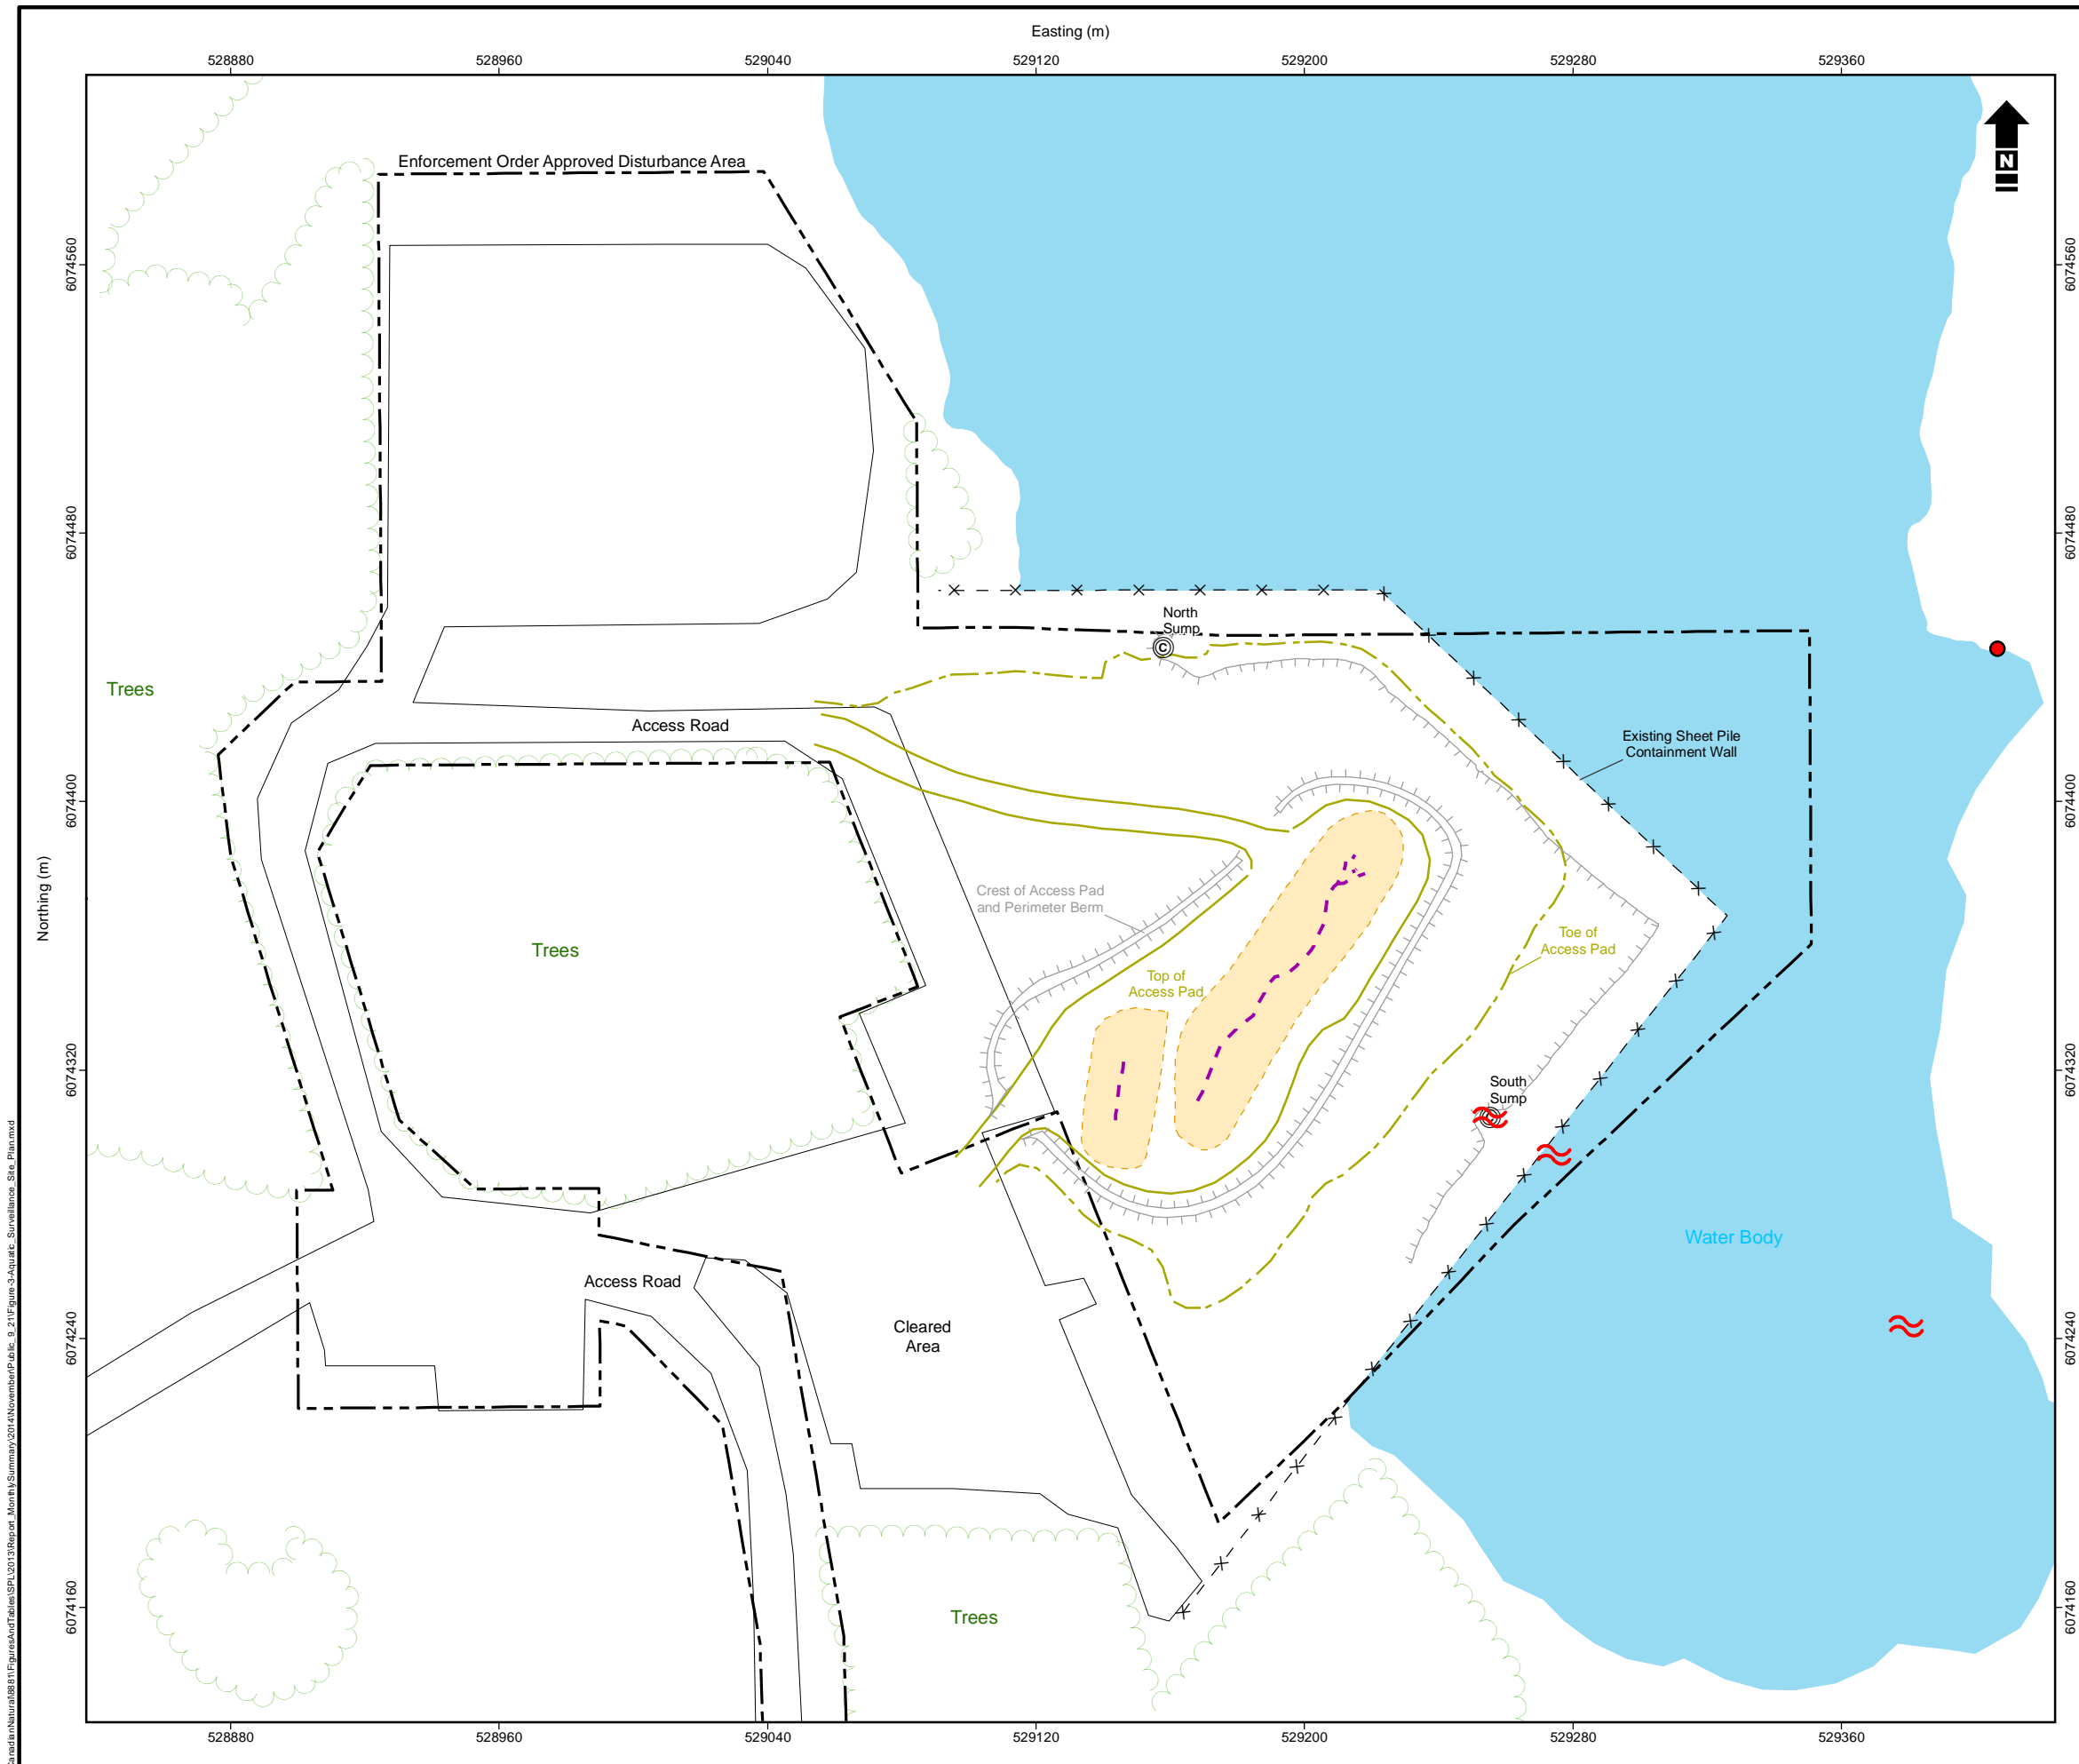
Aquatic Surveillance Site Plan

Sheen and bitumen emulsion pellets were observed in Basin 1 in the water body intermittently during the reporting period. The source of the sheen and pellets was attributed to small amounts of bitumen emulsion that were not cleaned from the water column and sediment after the original cleanup of bitumen emulsion release. All observed bitumen emulsion pellets and sheen were collected, using absorbent material, and disposed in the onsite hazardous waste bin. Over the reporting period, less than 0.5 L of bitumen emulsion has been collected from Basin 1.
