MONTHLY UPDATE REPORT - PRIMROSE SOUTH 09-21-067-04 W4M

SEPTEMBER 22 TO OCTOBER 19, 2015

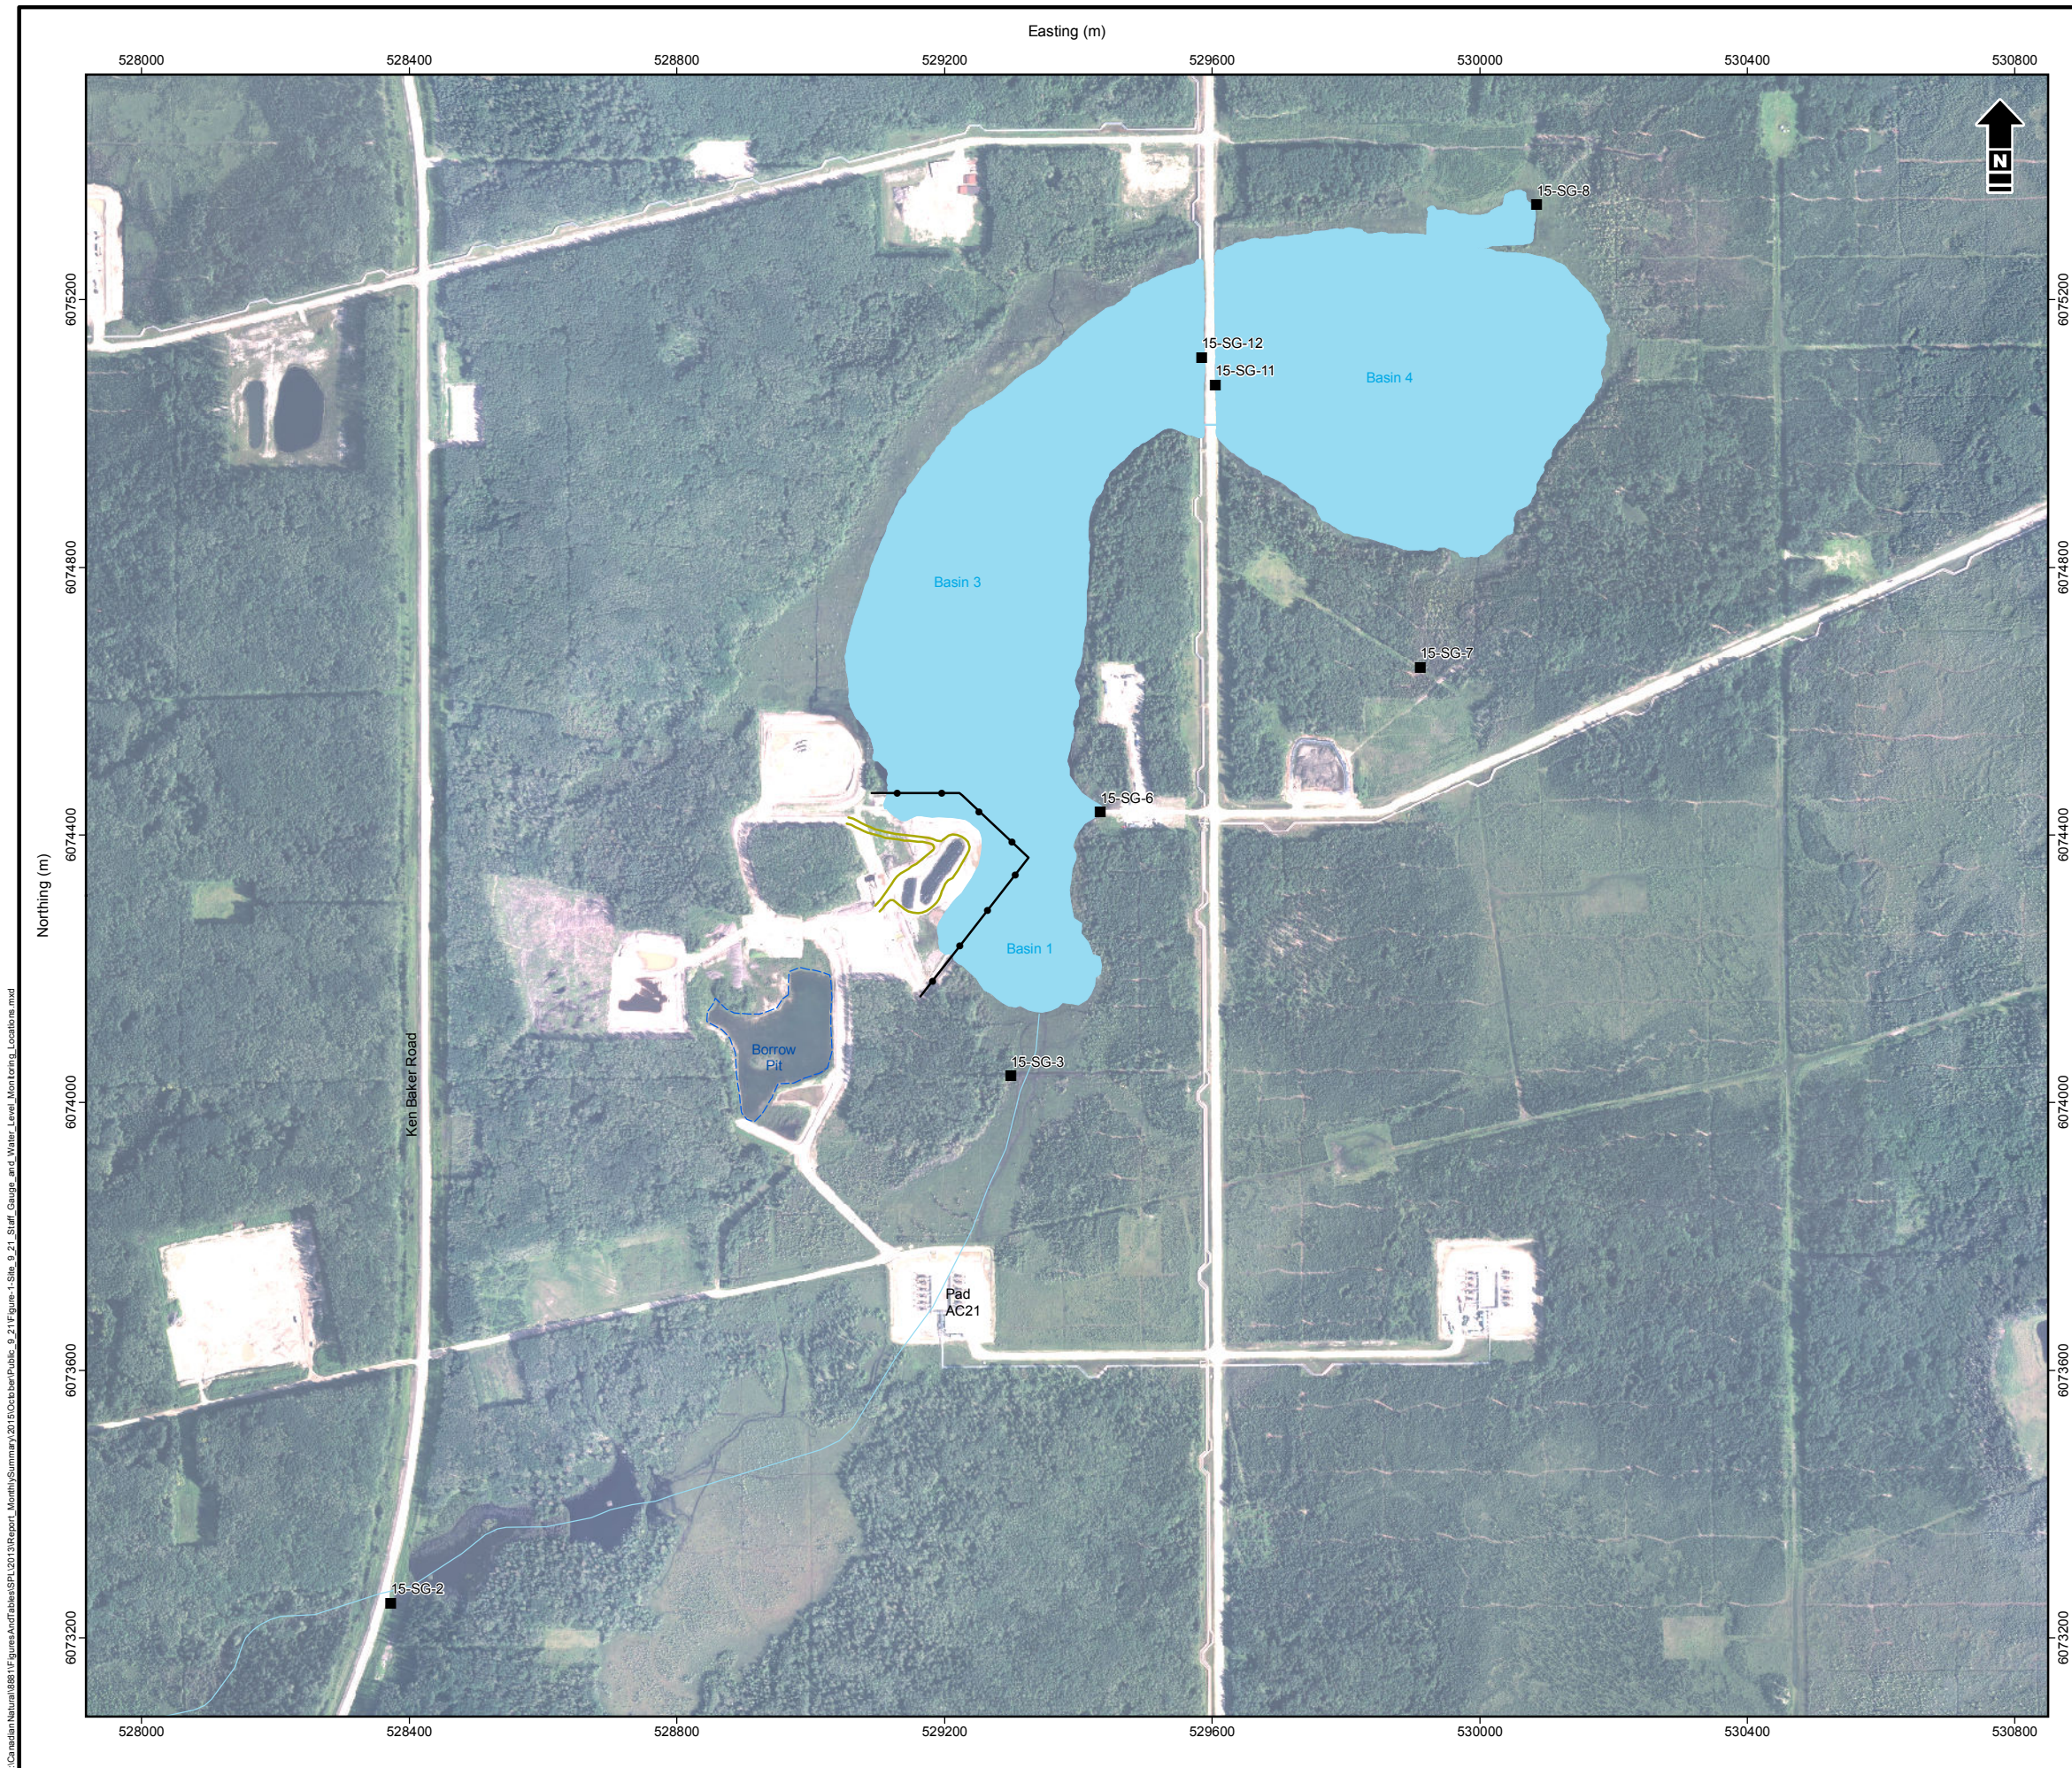
Site 9-21 Staff Gauge and Water Level Monitoring Locations

Staff gauges were monitored daily, throughout and following dewatering which took place from September 25 to October 16, 2015 at all locations (Figure 1). The 15-SG6 staff gauge was dry as of

October 10, 2015 and 15-SG12 staff gauge was dry as of October 1, 2015; and no subsequent readings could be taken. The results of the staff gauge readings and corresponding water elevations for Basins 3 and 4 are shown in Appendix A1. The results of the staff gauge readings and corresponding water elevations for the fen located south and west of the water body are shown in Appendix A2. The increased water levels at 15-SG2, measured since June 2015, were determined to have been caused by a beaver dam constructed near the staff gauge location.

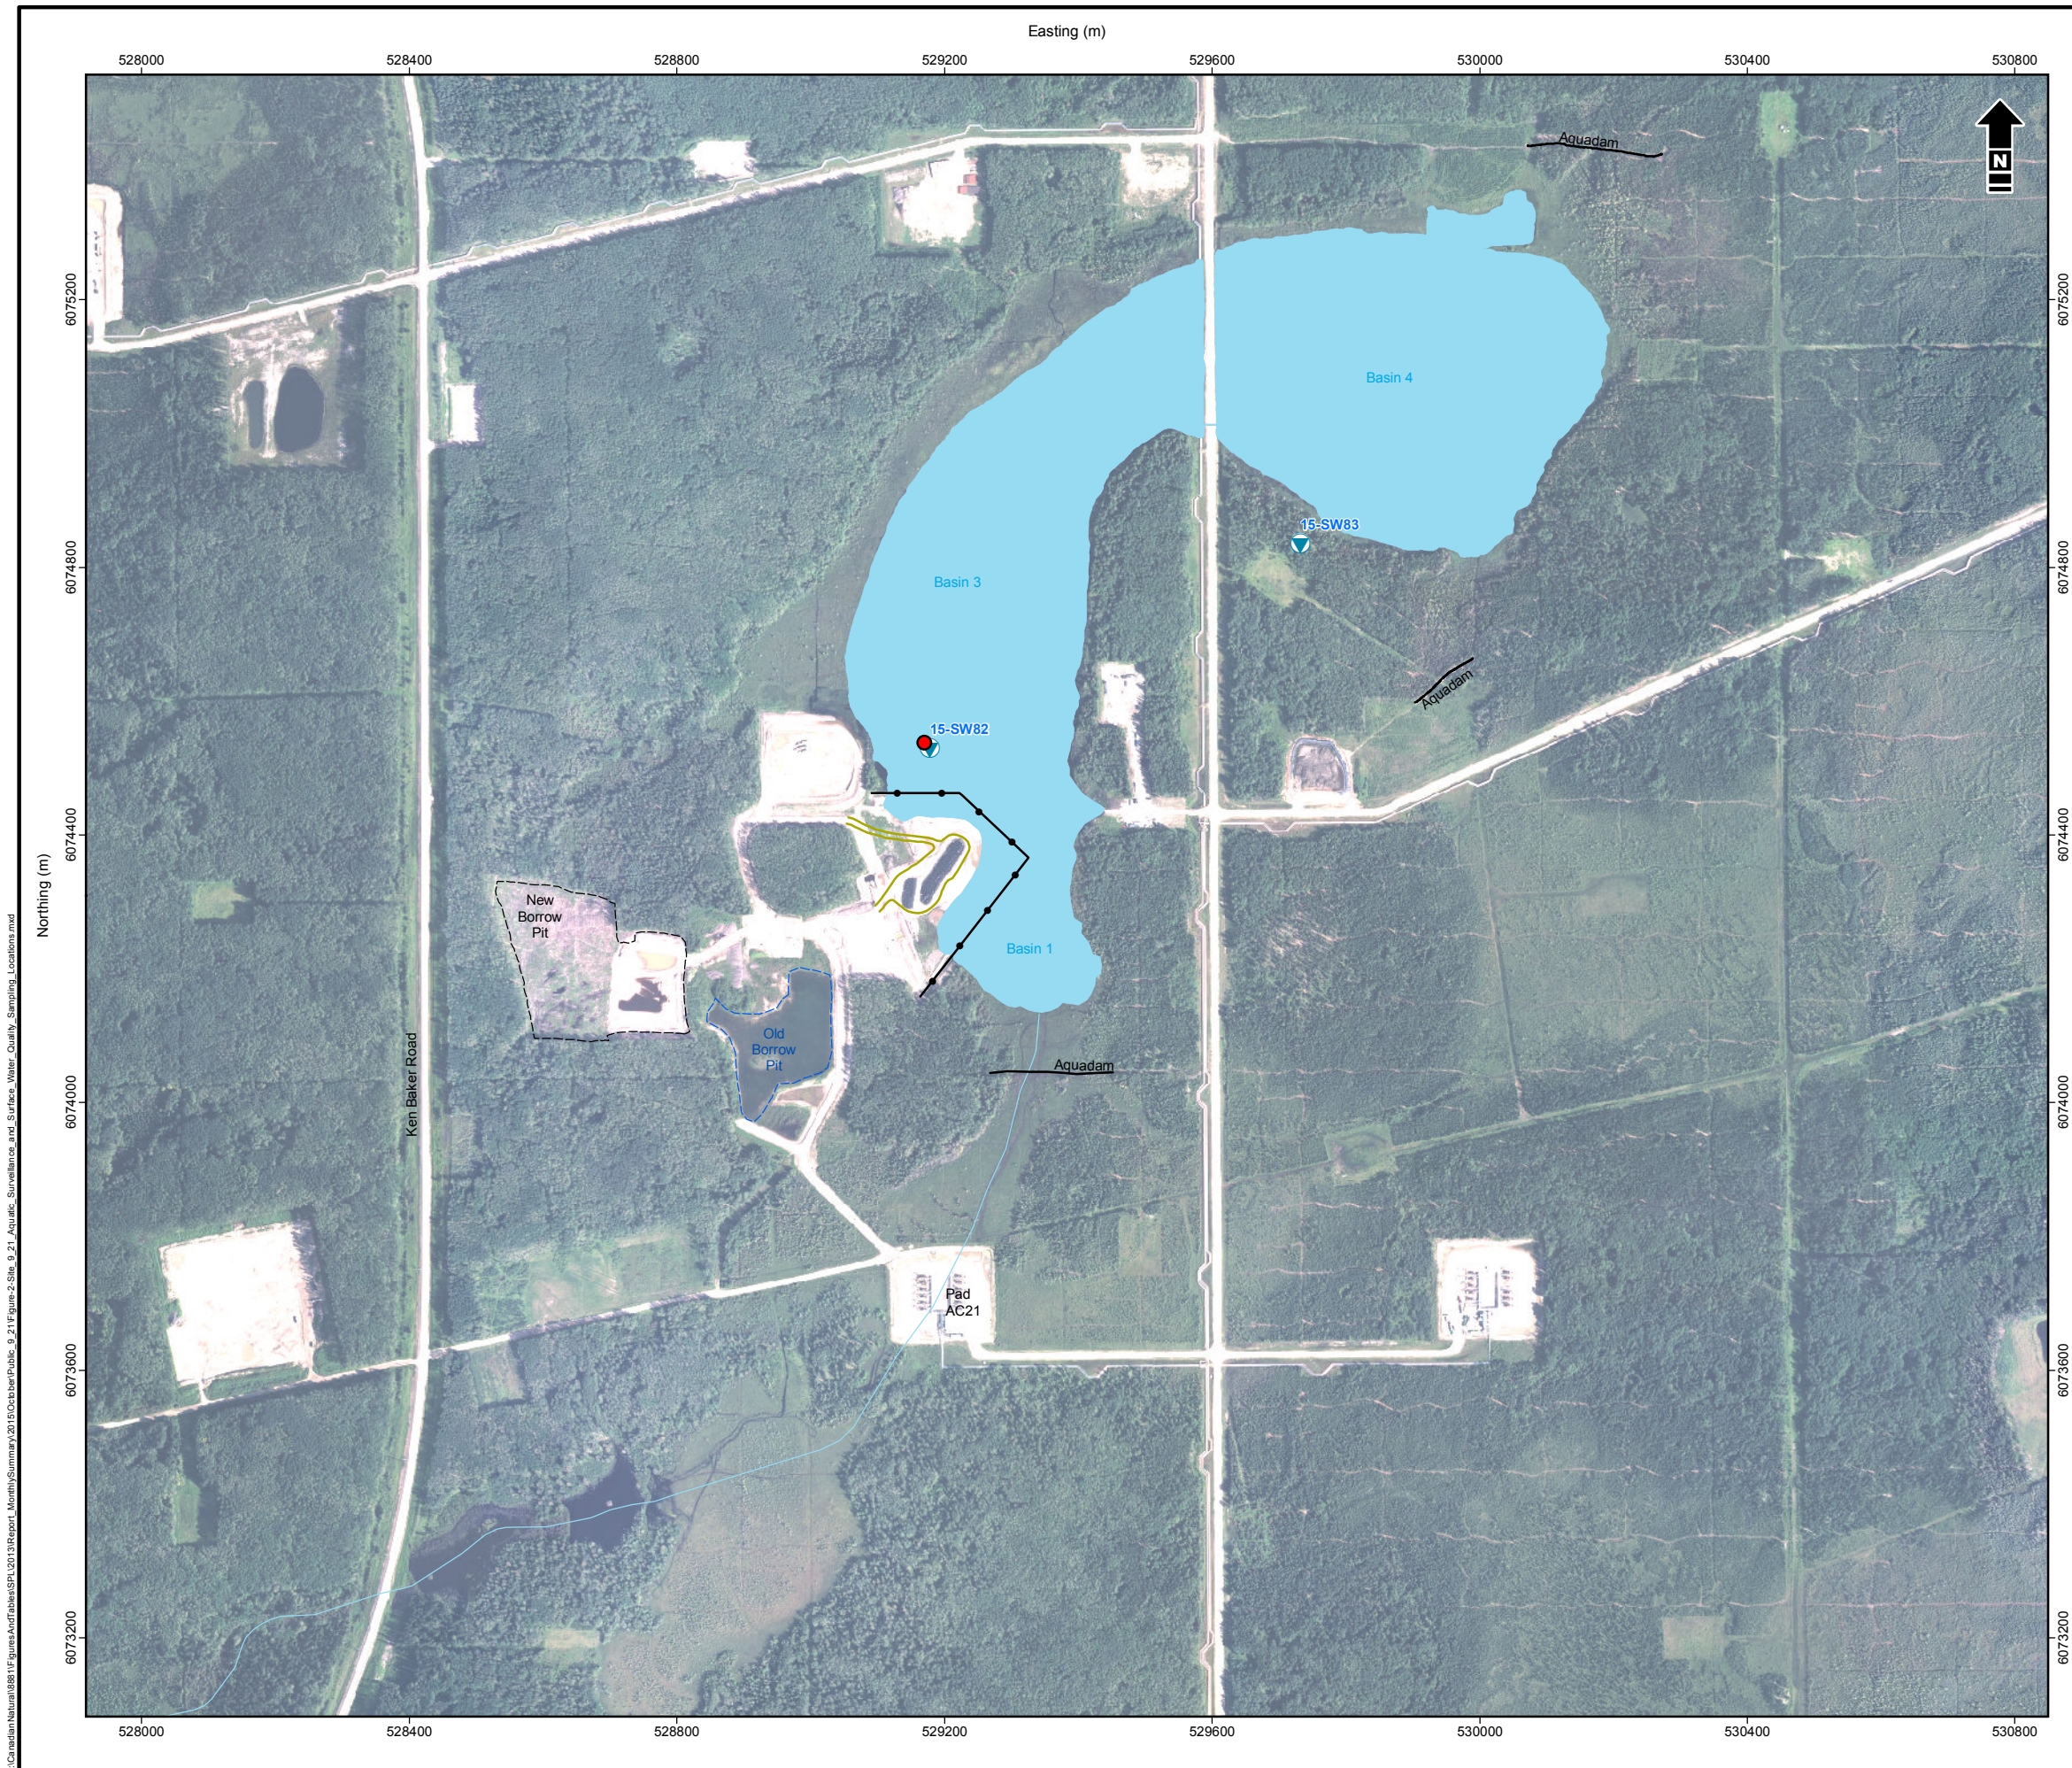
**Site 9-21 Aquatic Surveillance and
 Surface Water Quality Sampling Locations**

The water body as well as the discharge and storage areas associated with dewatering were monitored daily from September 22 to October 16, 2015. There were no reported occurrences of bitumen emulsion or sheen on the water body with the exception of a small volume (~150 mL) of bitumen emulsion that was observed in Basin 3 on October 15, 2015 that was likely residual bitumen emulsion from that released in June 2013. The observed bitumen emulsion was attached to vegetation and was collected in a glass sample jar and disposed of in the onsite hazardous waste bin.

On October 16, 2015, one water quality sample was collected from within Basin 3 in the vicinity of the bitumen emulsion found the previous day (15-SW82) and a second sample from within the discharge location into Basin 4 (15-SW83; Figure 2). All water quality results were less than laboratory detection limits. Laboratory analysis of the water samples collected from within Basin 3 and discharge area to Basin 4 were tested in the laboratory for benzene, toluene, ethylbenzene, and xylenes (BTEX); petroleum hydrocarbons fraction 1 (C₆-C₁₀, excluding BTEX) and fraction 2 (C_{>10}-C₁₆); and polycyclic aromatic hydrocarbons. The findings are provided in Appendix B.
