MONTHLY UPDATE REPORT - PRIMROSE SOUTH 09-21-067-04 W4M

NOVEMBER 18 TO DECEMBER 31, 2014

The Canadian Natural Resources Limited Primrose South in situ oil sands project is located in the Cold Lake Air Weapons Range approximately 65 km north-northeast of Bonnyville, Alberta. Canadian Natural operations staff discovered a bitumen emulsion flow to surface (FTS) area at 09-21-067-04 W4M on June 24, 2013. The bitumen emulsion FTS area is beneath an unnamed water body within the Canadian Natural Primrose South production area.

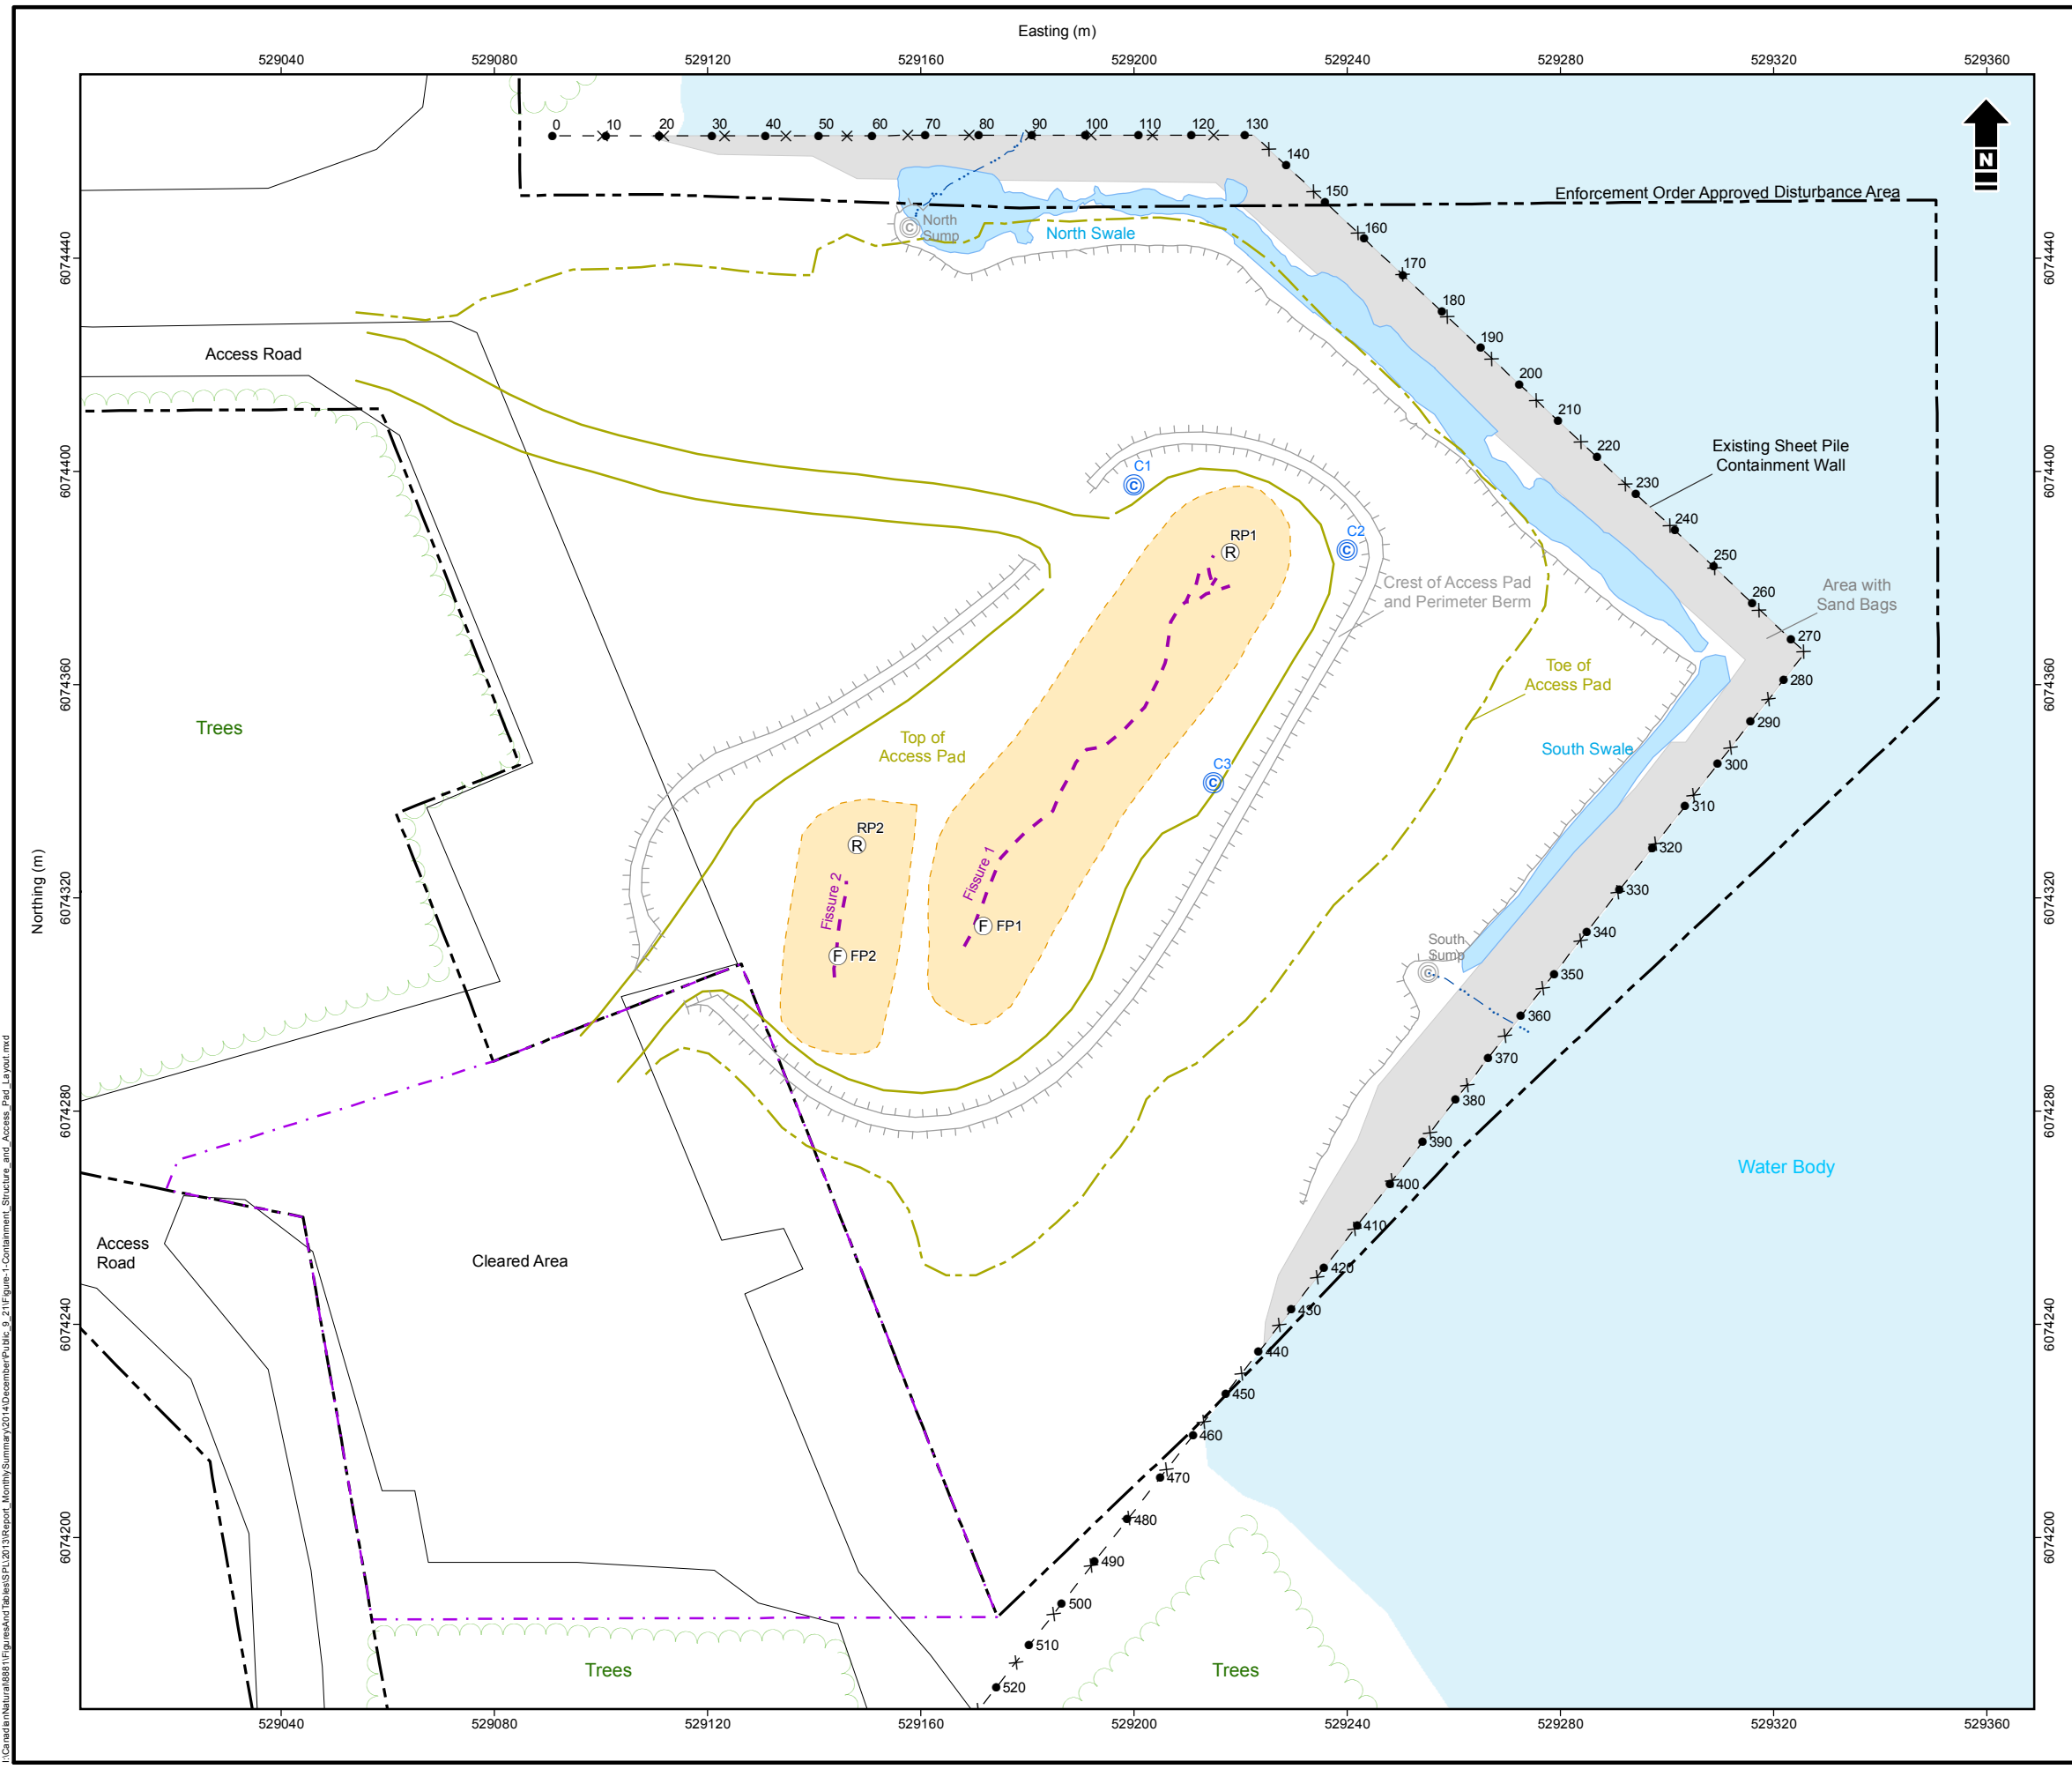
**Site 9-21 Containment Structure
 and Access Pad Layout**

Water that seeped across the containment wall was collected and pumped from inside the containment wall back into Basin 1 from two sumps located on the north and south sides of the wall (Figure 1). Water was pumped using automated pumps that were intermittently operational throughout the reporting period. Sheen was observed in the south sump on December 13 to 16, 2014, and pumping was temporarily suspended. The sheen was removed using absorbent pads, and a vacuum truck was used to remove 26 m³ of water from the south swale to keep water from overflowing the swale. Pumping into the water body resumed on December 15, 2014, when the laboratory reports were received. Daily monitoring of both the north and south sumps was conducted from November 18 to December 18, 2014.

With the fissure containment structures (FCSs) and access pad complete, and following the reinforcement of the containment wall (completed on December 18, 2014), the automated pumping systems and sumps were decommissioned. The area within the containment wall was allowed to naturally flood with water from the water body, restoring the water level in the contained area to that of the water body.

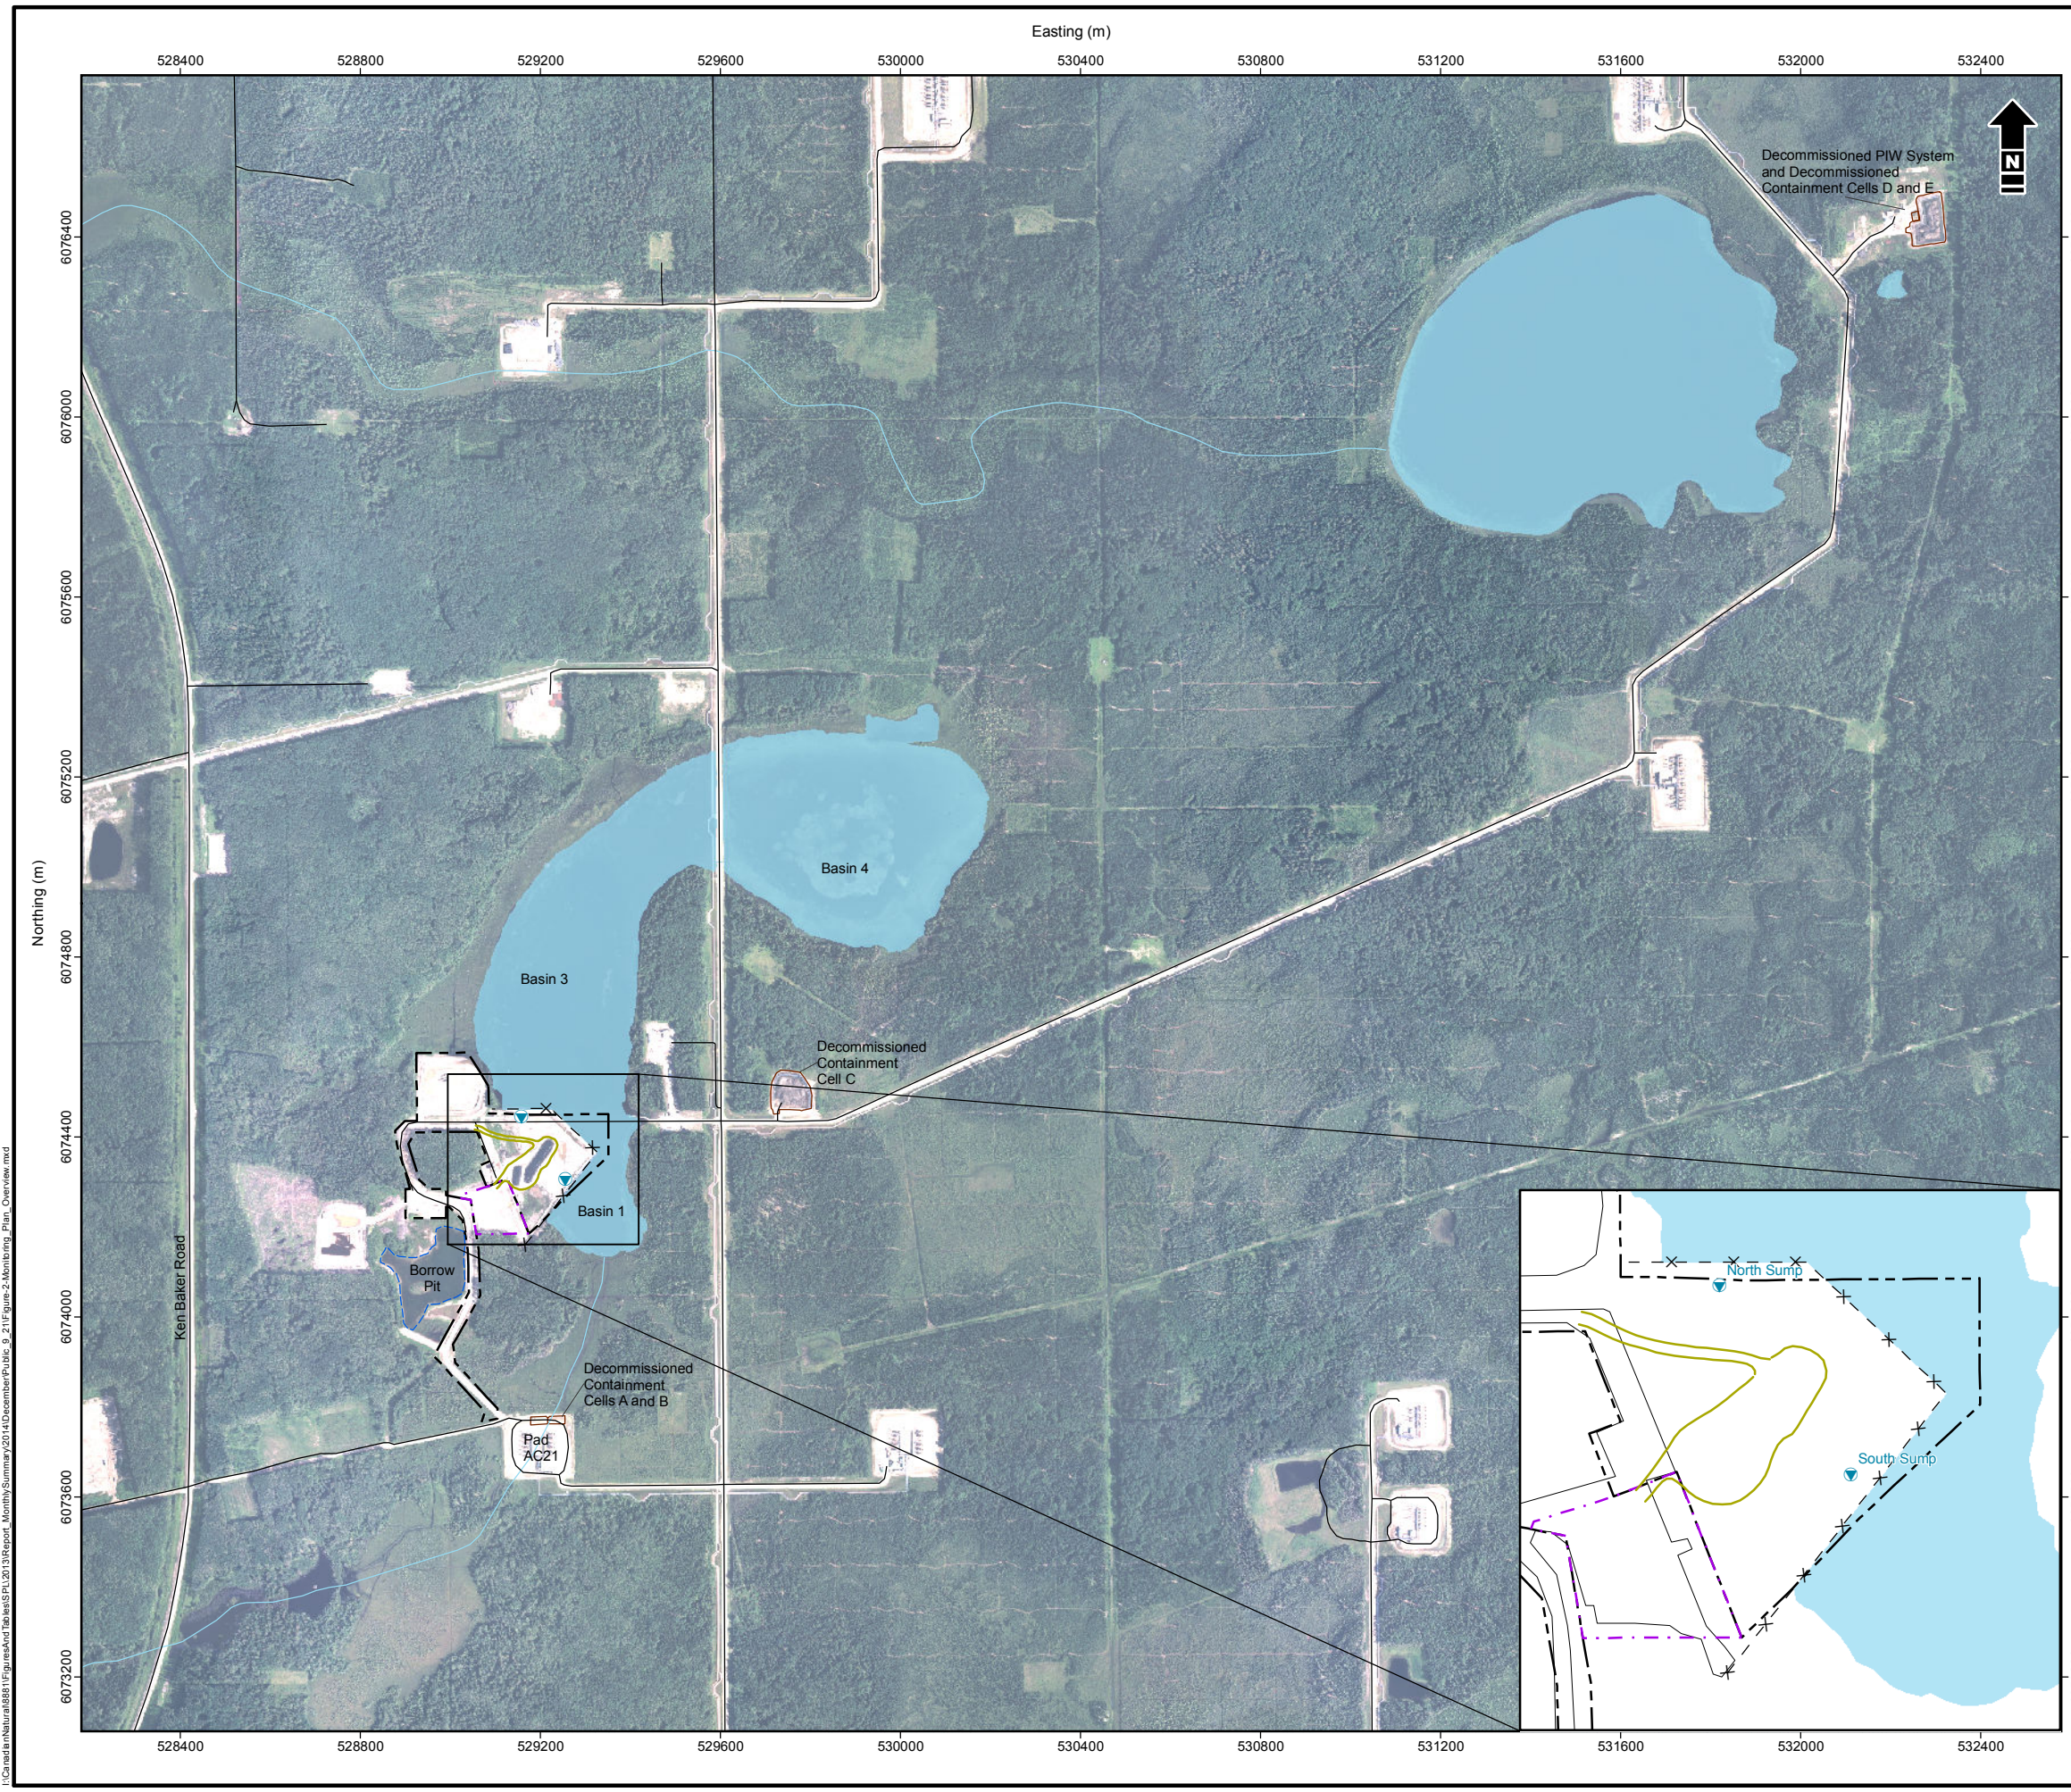
Monitoring Plan Overview

Samples of water from inside the north and south sumps (Figure 2) were obtained and tested in the laboratory for concentrations of petroleum hydrocarbons (PHCs). Results indicated that PHCs were not present at levels above relevant environmental guidelines, with the exception of pyrene in the south sump sample collected on December 13, 2014. Results are presented in Appendix A.
