1 EXECUTIVE SUMMARY

1.1 EXECUTIVE OVERVIEW

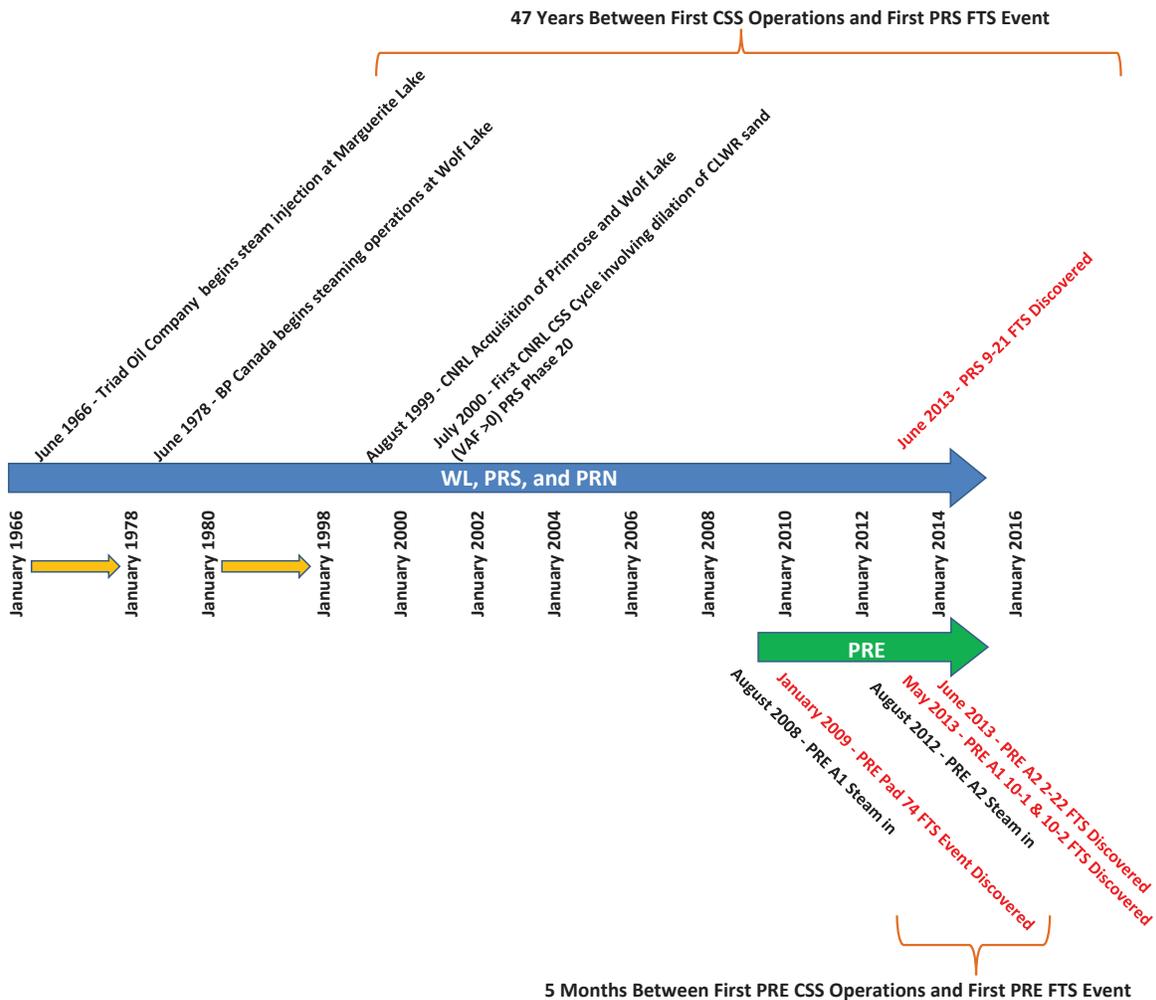
Primrose and Wolf Lake Cyclic Steam Stimulation (CSS) started some 50 years ago, and current development design and execution of CSS operations have been undergoing continuous refinement for the past 13 years in the area. The occurrence of multiple FTS events over a broad area, in a narrow time period, strongly suggests a repeatable cause (Figure 1.3-1). The fact that the four FTS events all occurred in recent history, suggests that the enabling conditions only existed with sufficient overlap in this same time period, which allowed the FTS events to occur.

Figure 1.3-1 Timeline of Primrose and Wolf Lake (PAW) operation with FTS events.

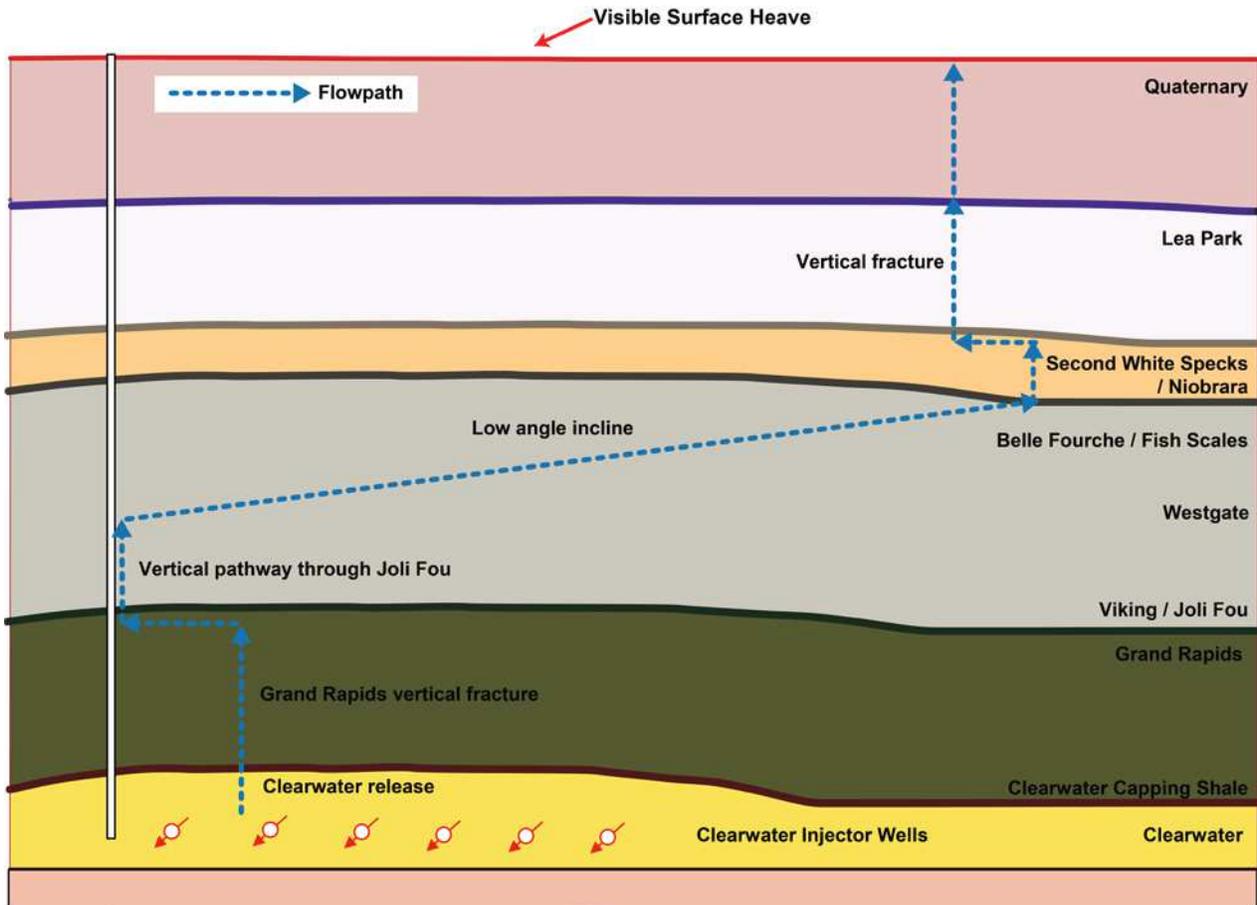
Figure 1.3-2 provides a schematic of the pathway the bitumen emulsion took as it travelled from the Clearwater Formation to the surface.

Figure 1.3-2 Schematic of the four enabling conditions showing the flow path to the surface.

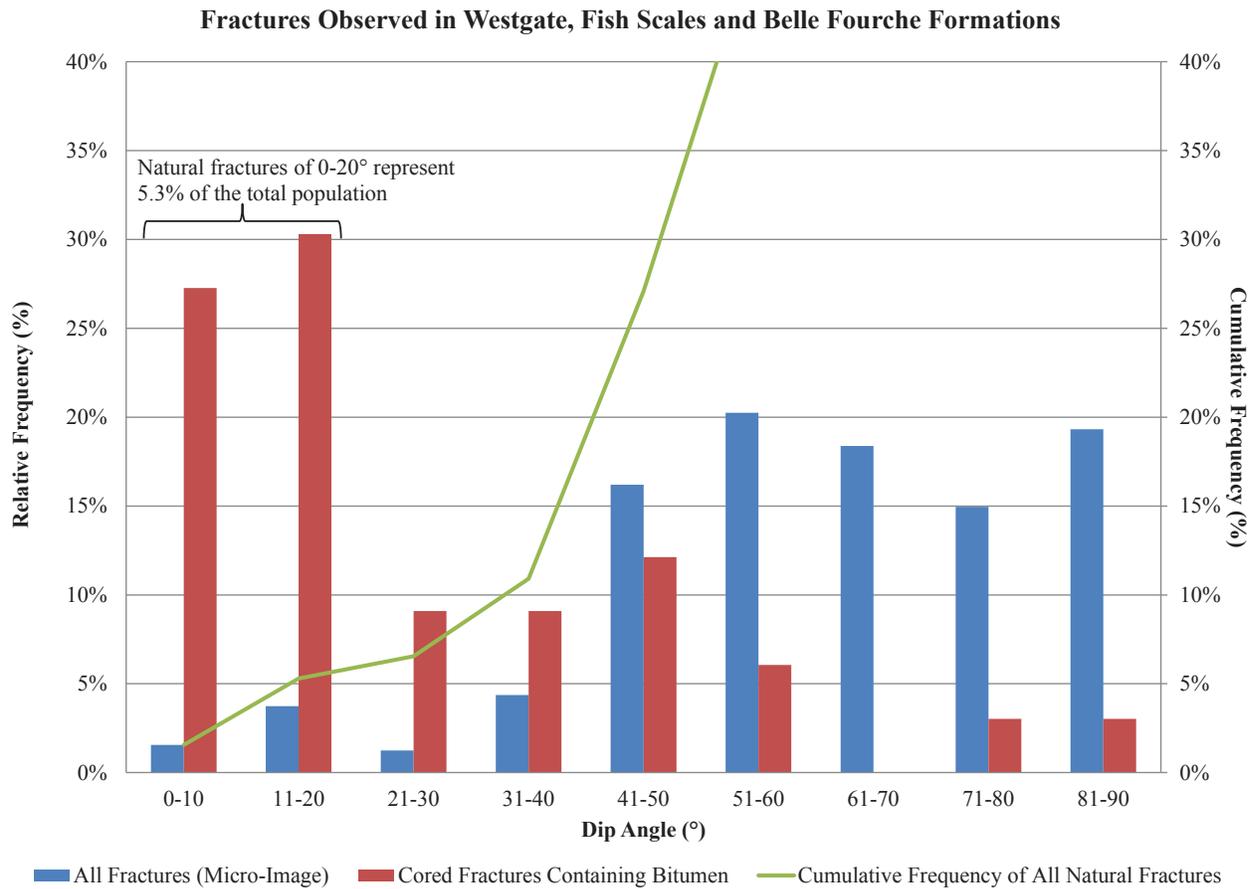
Hydraulically induced fracture growth is controlled by in-situ stresses. Determinations of in-situ stresses from the majority of the Colorado Group shales, indicate that bitumen emulsion would hydraulically induce horizontal fractures. Despite this, bitumen emulsion shows from the four FTS areas demonstrate that the flow path follows a net low angle (< 10°) climb through the Westgate, Fish Scales and Belle Fourche formations (Table 1.3-1). This pattern of net low angle climb is also evident in core data, where bitumen filled fractures are predominantly in a small subset of low dip angle fractures representing 5% or less of the total available natural fractures (Figure 1.3-3).

Figure 1.3-3 Dip angles of cored fractures containing bitumen emulsion. The low angle inclined FTS pathway likely used 5% or less of the total natural fracture population in the Westgate to Belle Fourche formations.

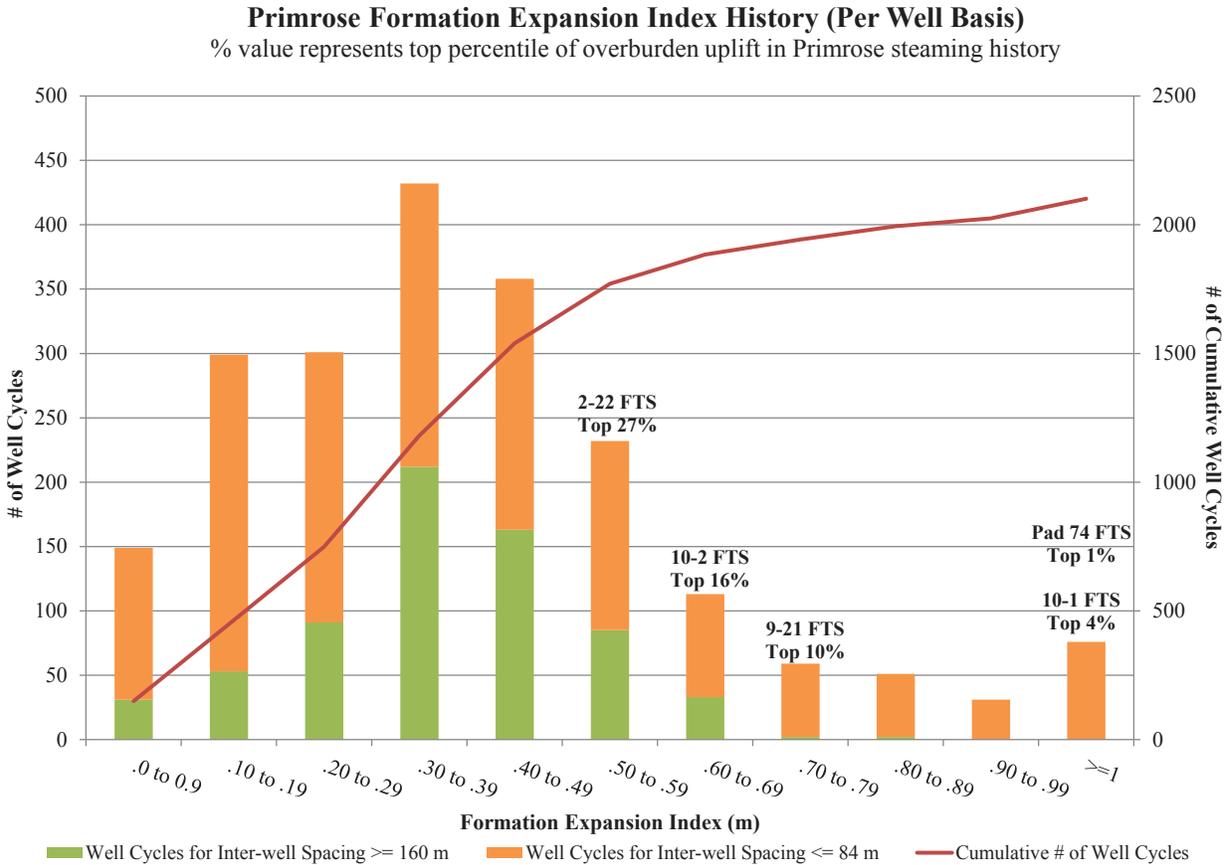
A review of the estimated uplift (as represented by the Formation Expansion Index [FEI]) in Primrose, shows that a high FEI (large uplift) is associated with the flow to surface events. Figure 1.3-4 shows the distribution of individual well FEIs from a total of 123 phase cycles. The distribution of all the flow to surface events is noted in this population. It can be seen that FTS events are confined to the top 27% of

this distribution, with the majority in the top 10%. The correlation of FTS to significant uplift induced stress changes is supported by this pattern.

Figure 1.3-4 Primrose FEI distribution with the FTS events confined to the top 27%.
