## PRIMROSE UPDATE

Reporting Period August 25 - 31, 2013

Canadian Natural

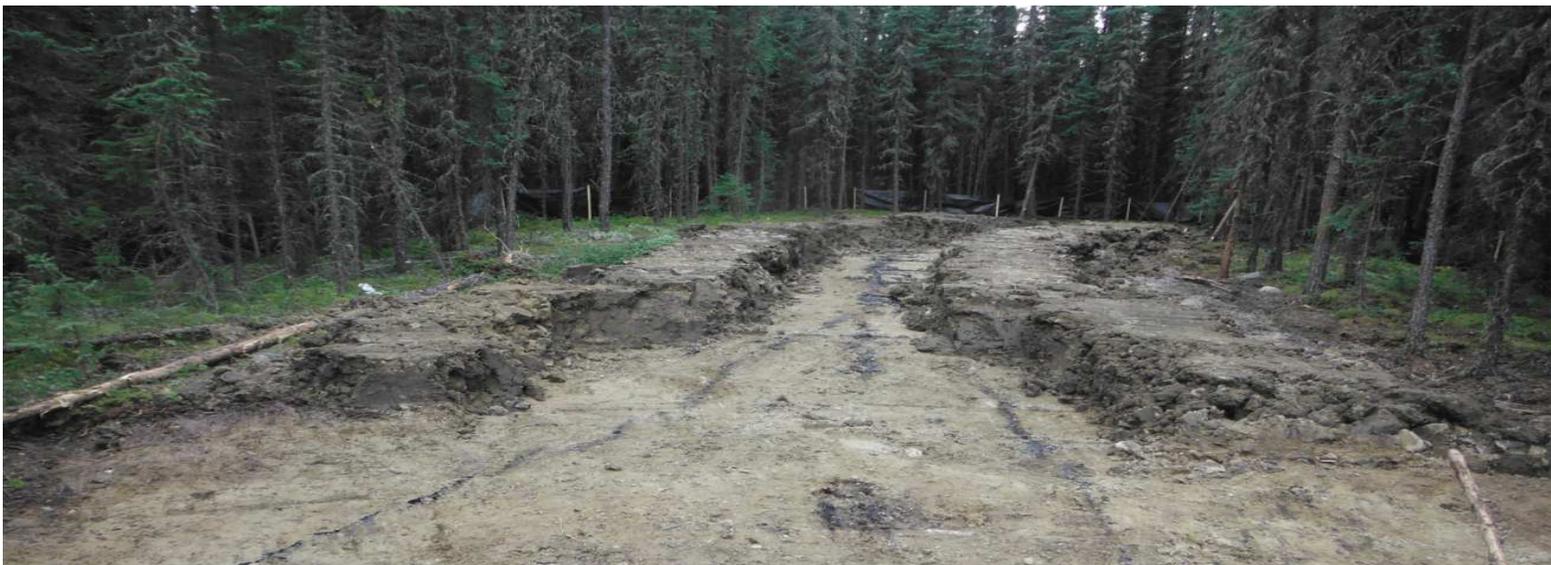
*Exposed Fissure at 2-22*
